Customer Satisfaction Program

N172130461 (18216) Loss of Propulsion Due to Low Cell Voltage

Release Date: December 2019

Revision: 00

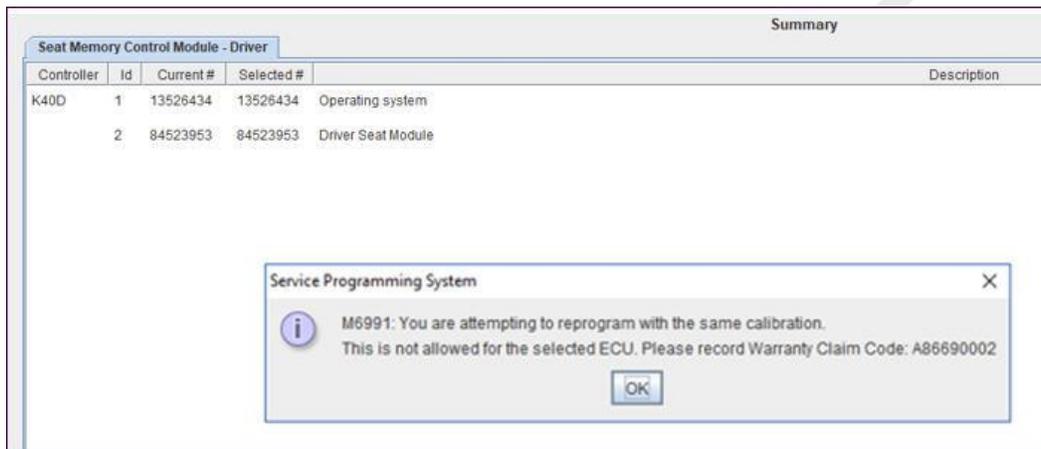
5164840

Note: If the Same Calibration/Software Warning is noted on the SPS Summary screen, record the warranty claim code (WCC) and select OK and follow screen instructions. The WCC is located in the Service Programming System dialogue box of the SPS Summary screen. No further action is required. Refer to the Warranty section of the bulletin.
